Observed Sanitary Dressing Deficiencies and Ineffective Application of Interventions at Veal Slaughter Establishments

FSIS conducted a review of Food Safety Assessments (FSAs) and onsite visits to identify concerns unique to veal slaughter. The results of the review indicated that many veal slaughter establishments have not implemented sanitary dressing and process control procedures sufficient to prevent carcass contamination and the creation of insanitary conditions.

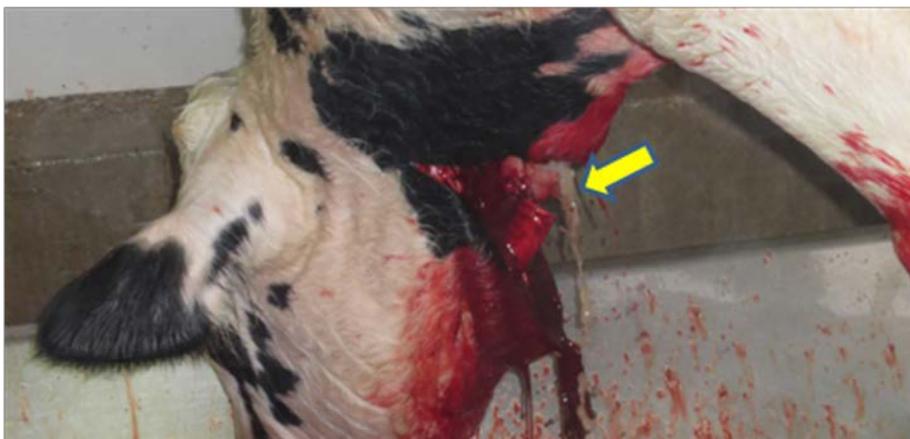
Photo 1 Cutting through the weasand (esophagus) during sticking

In this photo, we see that the establishment uses a large cut to bleed the calf, and that ingesta is leaking from the esophagus during bleeding (yellow arrow). FSIS observed employees cutting through the weasand (esophagus) during sticking. This practice resulted in ingesta contaminating the carcass and head. FSIS also observed employees removing the head without closing the weasand. FSIS recommends that the establishment use the smallest cut possible to accomplish bleeding and not to cut the weasand during sticking and bleeding. FSIS recommends that establishments close the weasand after rodding prior to head removal.

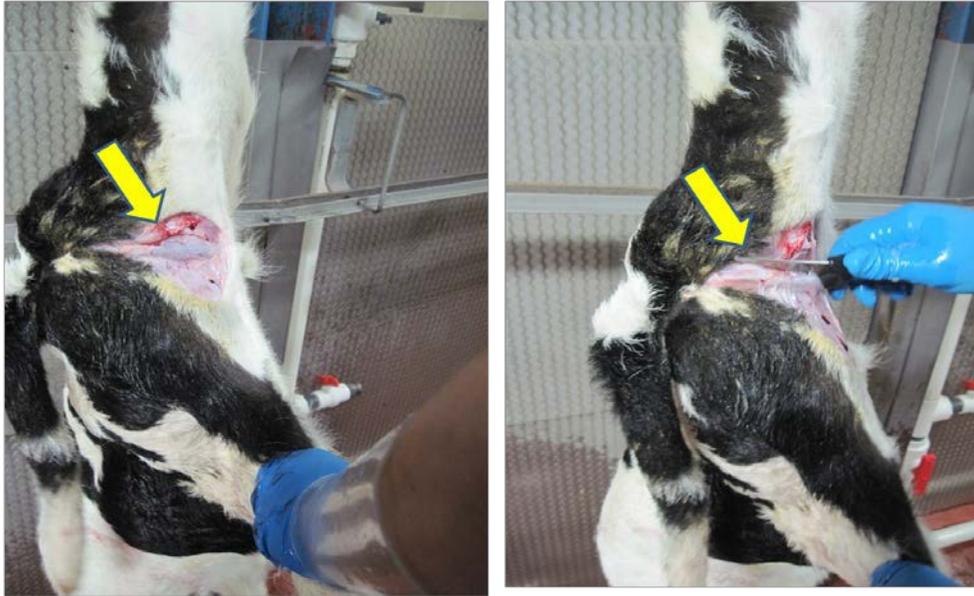
Cut the Aitch Bone

Onsite visits to veal slaughter establishments and reviews of FSAs showed that establishments were cutting through the hide and further dressing the carcass without sanitizing knives, gloves, and equipment adequately to prevent the creation of insanitary conditions. An example would be an employee making a “dirty cut” (one through the hide, left photo) and continuing to cut through aitchbone (yellow arrow) without sanitizing the knife after making the dirty cut. Another example (not pictured) of this would be a veal slaughter establishment further processing veal carcasses with the hide-on. Proper hide removal is a critical step in preventing carcass contamination and the creation of insanitary conditions. While opening the hide (except for the original incisions for sticking and starting the skinning operations at the poll and shanks), FSIS recommends that the employee direct the knife blade toward the hair side of the skin to prevent contaminating the flesh with cut hair (not shown). After making the “dirty cut” and exiting the hide, FSIS recommends that the employee sanitize his knife and glove before making another cut (in this case, cutting through to the aitchbone, right photo).

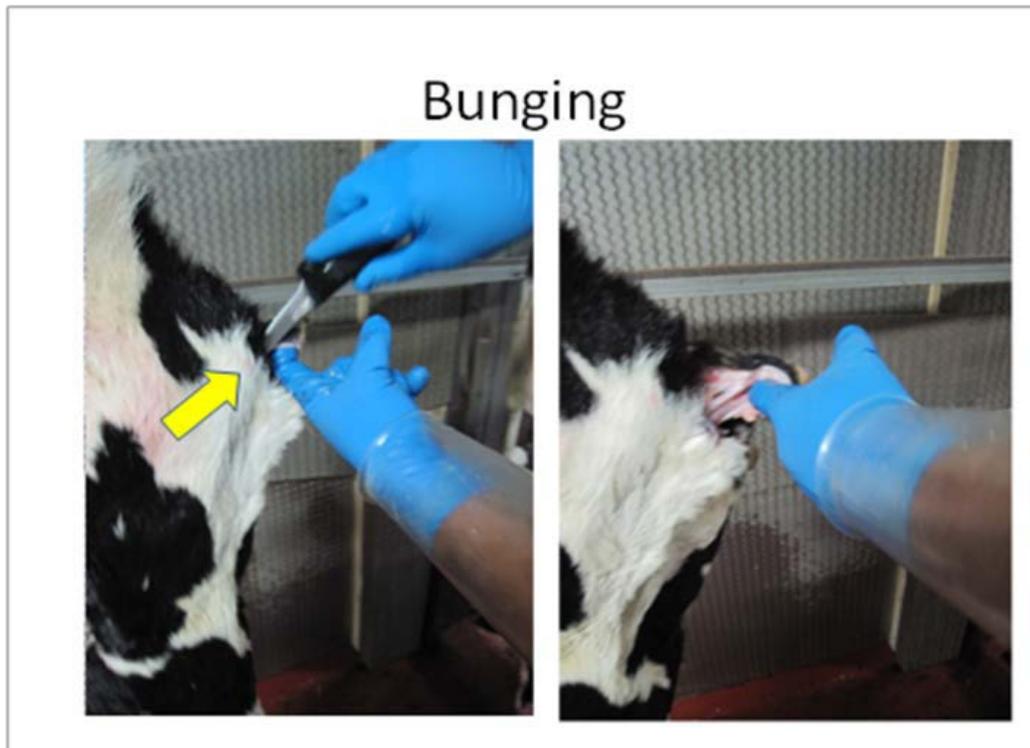
This concept of sanitizing after the “dirty cut” can also be seen with bunging. The employee makes the “dirty cut,” in this case cutting around the tissue surrounding the anus (yellow arrow, top left photo). The employee then sanitizes his knife and gloves before further cutting the exposed tissue (top right photo). FSIS recommends that establishments remove the hide prior to cutting into the carcass. Tying and bagging the bung (not shown) is also an important step to preventing carcass contamination.

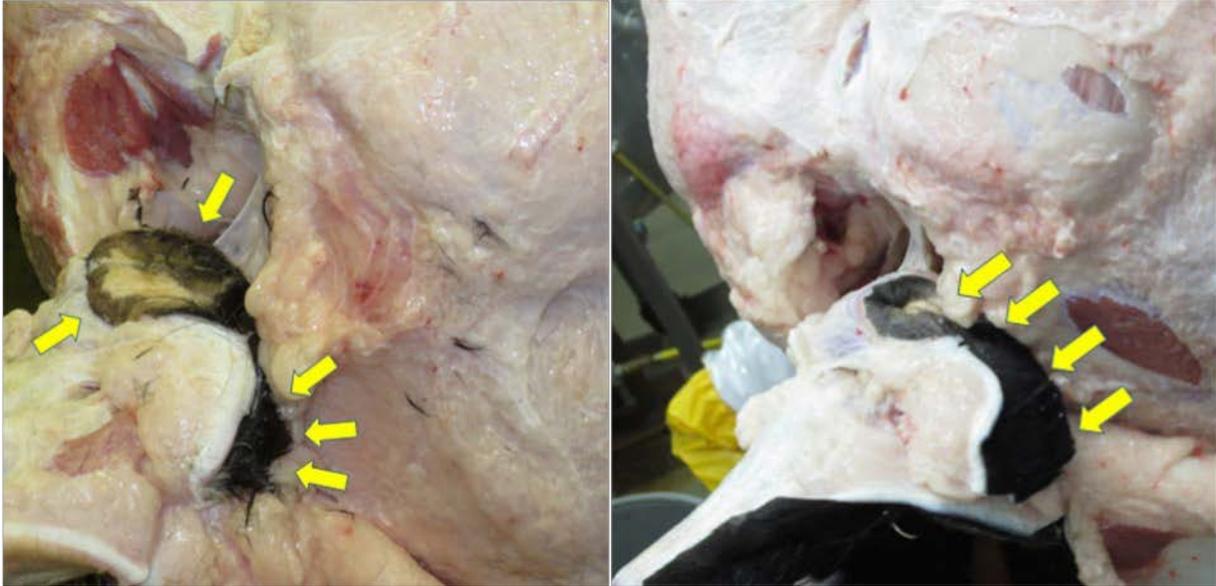
These photos show the impact of the establishment failing to bag and tie the bung. The contaminated bung is contacting the exposed carcass (yellow arrows). When establishments apply hot water or antimicrobial interventions to an exposed bung, it further spreads contamination. FSIS recommends that establishments tie and bag the bung in a sanitary manner.

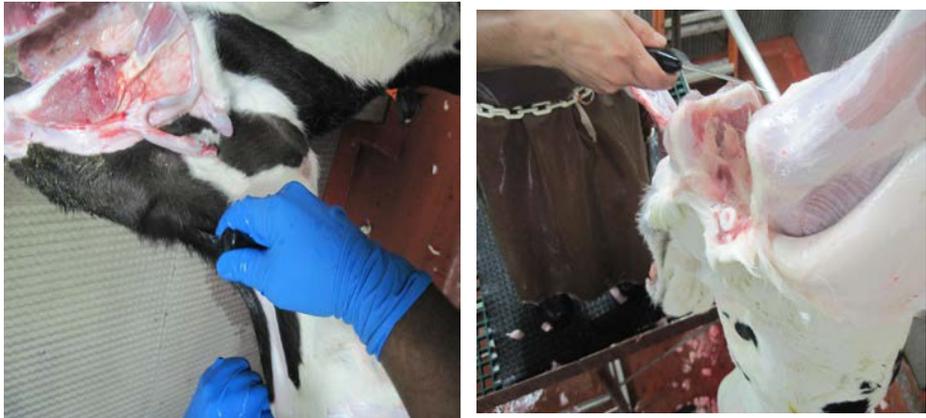
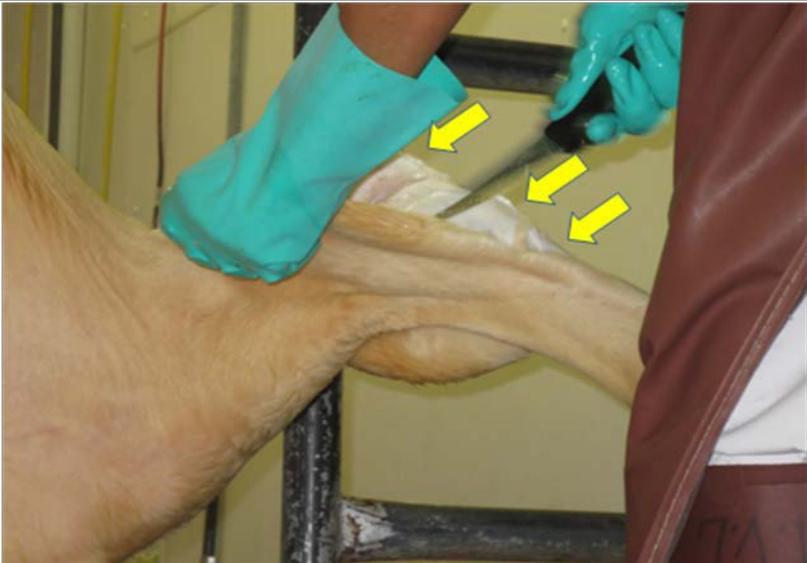
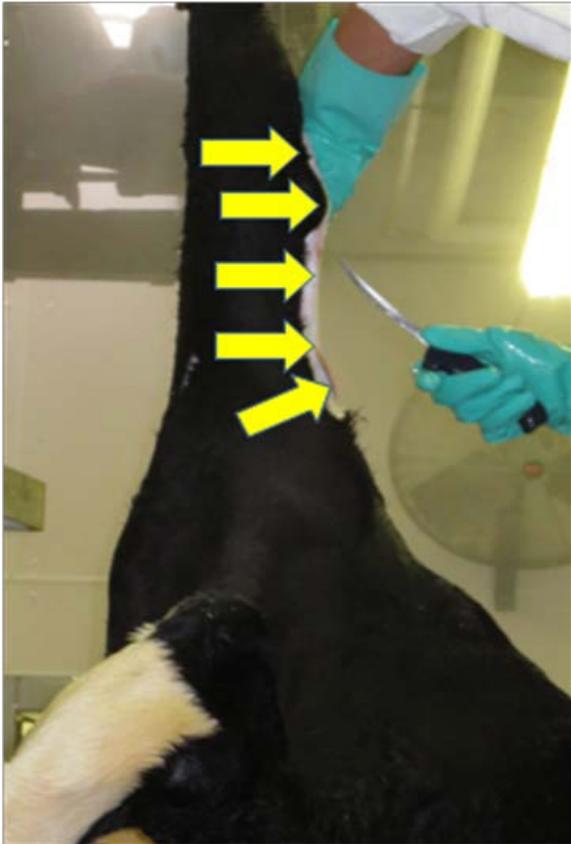
Legging

These photos show the “legging” process, a part of the hide removal process during which the establishment personnel remove the hide from the hindlimbs. Establishment personnel may introduce contamination at the pattern lines (along the incision lines through the hide, as the arrows show in the two bottom pictures). It is important that establishments prevent contamination throughout the slaughter process and remove contamination promptly when it occurs. The establishment can do this through knife trimming or steam vacuuming.

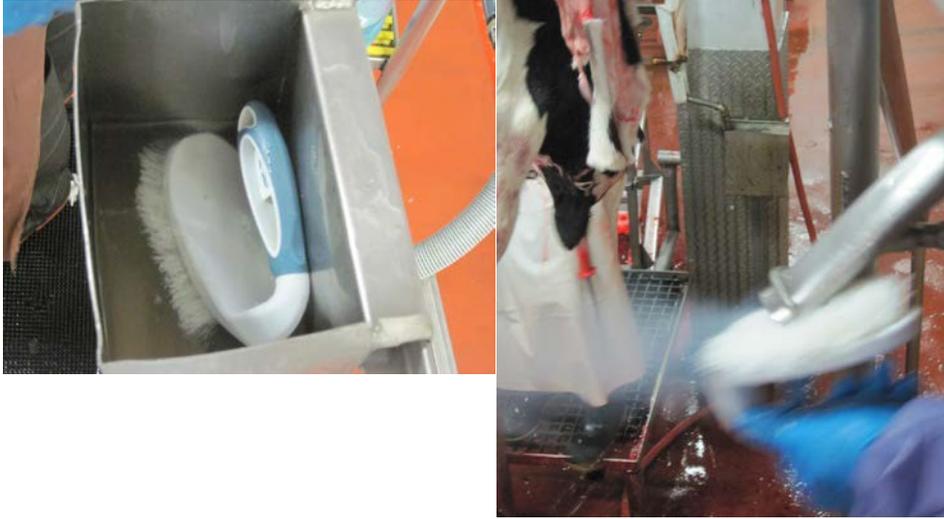
Sanitize and Remove Debris from Steam Vacuum

Steam vacuuming is a useful intervention for establishments to apply along the pattern lines and for removing incidental contamination. FSIS observed (not shown) employees applying heavily contaminated steam vacuums to carcasses. The purpose of these photos is to remind IPP of the importance of cleaning and sanitizing equipment as often as necessary to prevent the creation of insanitary conditions and cross contamination.

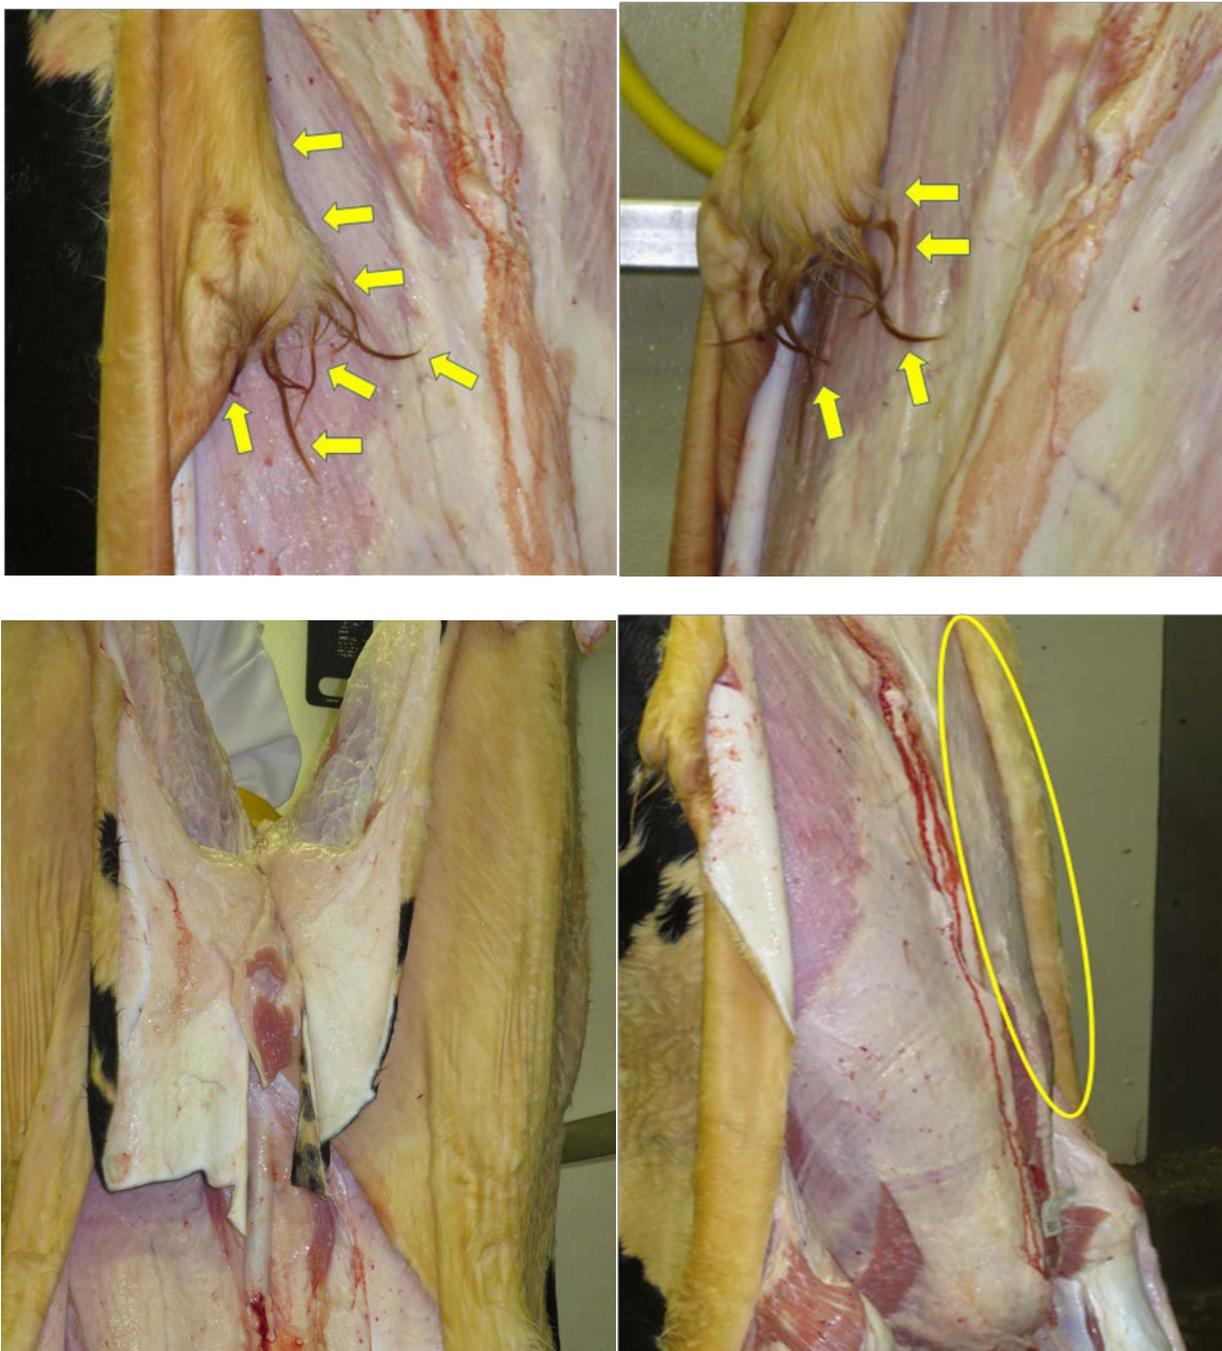
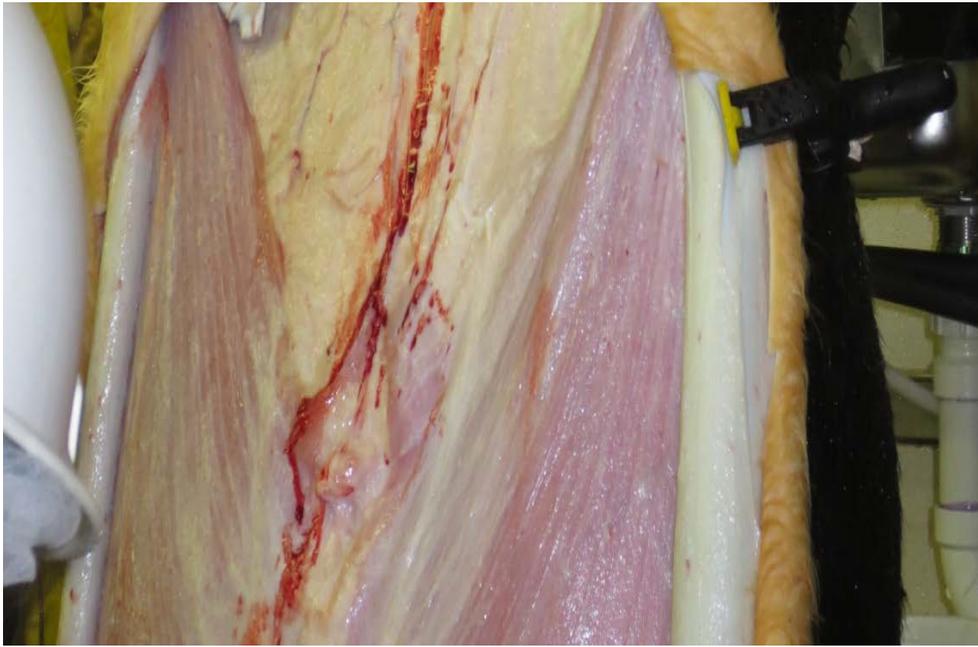
These photos show hide and hair touching the carcass when being removed, potentially allowing the dirty exterior side to touch the carcass. In the bottom left photo, the leg hide flaps are contacting the carcass. The bottom right photo shows hide flaps that have curled under after hide removal (as seen inside the yellow oval) and are contacting the carcass. FSIS recommends that establishments prevent the hide from contacting the carcass during hide removal. The photo below shows the use of hide clips as one method of preventing hide from contacting the carcass.

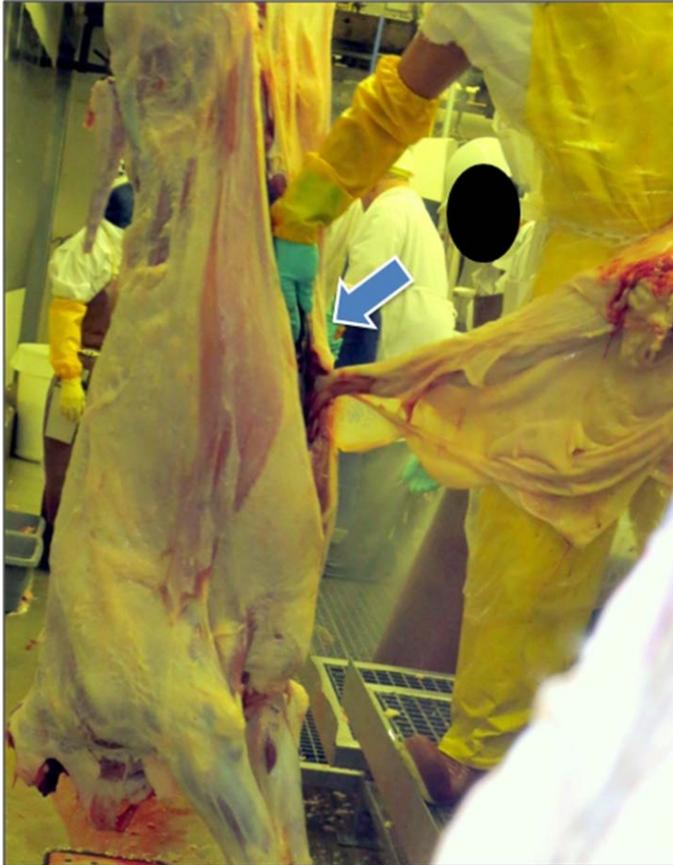
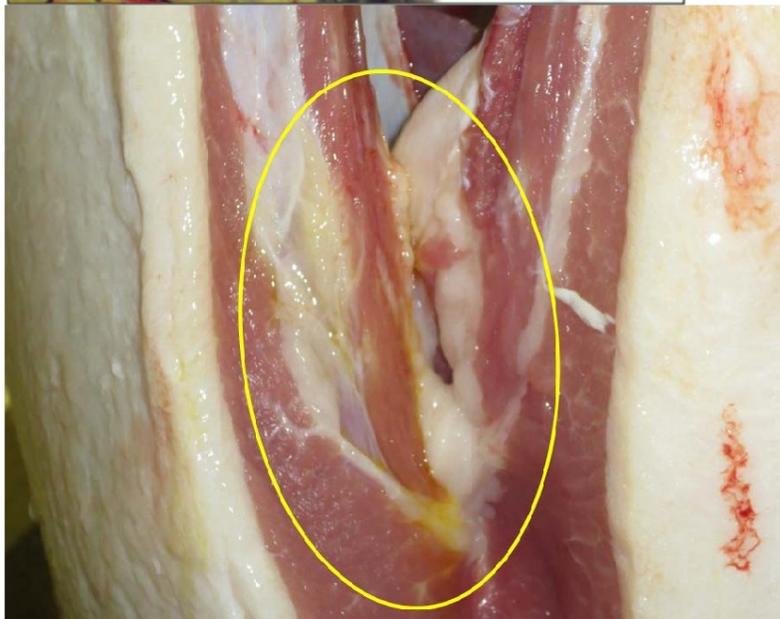
These photos show the establishment puncturing the paunch and intestines during evisceration (top photo, at blue arrow) causing carcass contamination with ingesta (bottom photo, inside yellow oval). FSIS recommends that establishments perform proper sanitary dressing procedures during evisceration to prevent puncturing the paunch and intestines.

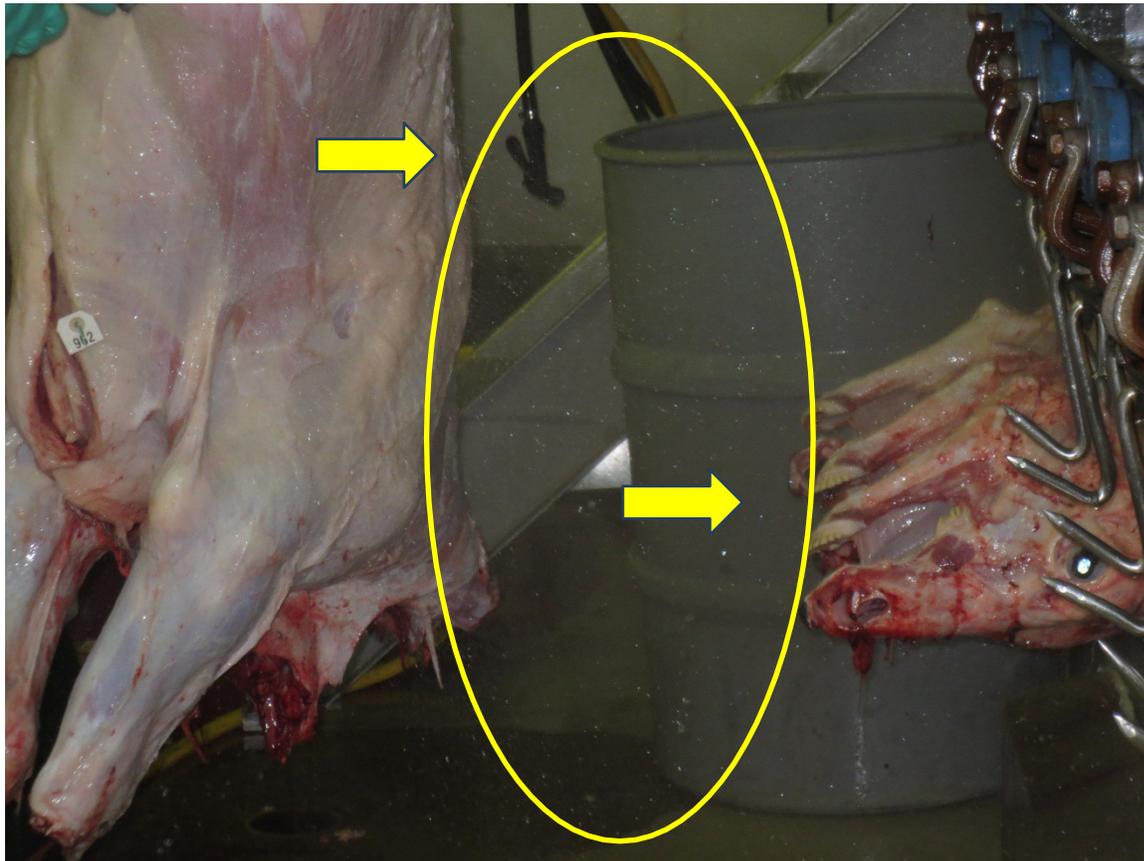
This photo shows cross contamination of heads from a spray applied to the carcass (water sprayed onto carcass in the direction of the arrows, water spray seen within the yellow oval). The establishment failed to take measures (e.g., adequate distance or shields) to prevent cross contamination of adjacent heads. Cross contamination (not shown) can also occur while employees spray equipment, the floor, and other surfaces if the establishment does not take appropriate precautions to prevent overspray from contacting carcasses. Also, it is important that carcasses are free of visible contamination prior to entering wash cabinets or the manual application of water or antimicrobial sprays. Otherwise, the intervention could further spread the contamination.

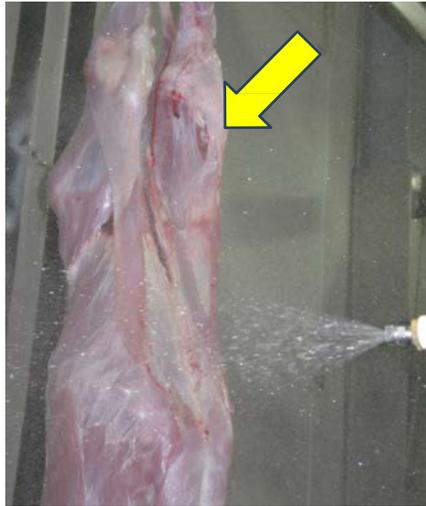
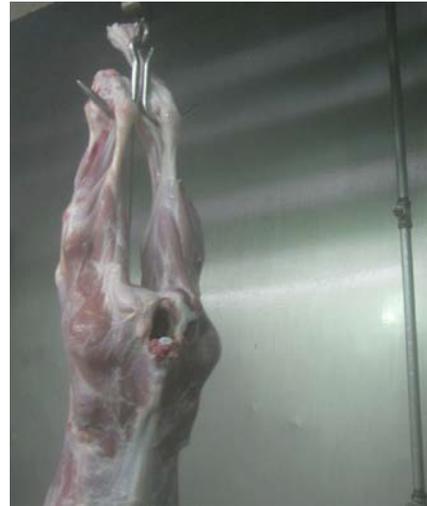
These photos show the practice of suspending a carcass from a single hook, which prevents antimicrobial and hot water interventions from achieving carcass/product coverage. Carcass coverage –ensuring that the entire carcass surface is treated -- is necessary for the intervention to operate effectively and as intended. Additional information is included in FSIS Notice 17-12 Verification of Antimicrobial Intervention Coverage of Carcass or Product at Veal Slaughter and Beef Fabrication Establishments. IPP verify that establishments are implementing their interventions effectively (i.e., according to the establishment’s scientific support) during the observation component of the appropriate Hazard Analysis and Critical Control Point (HACCP) verification task.

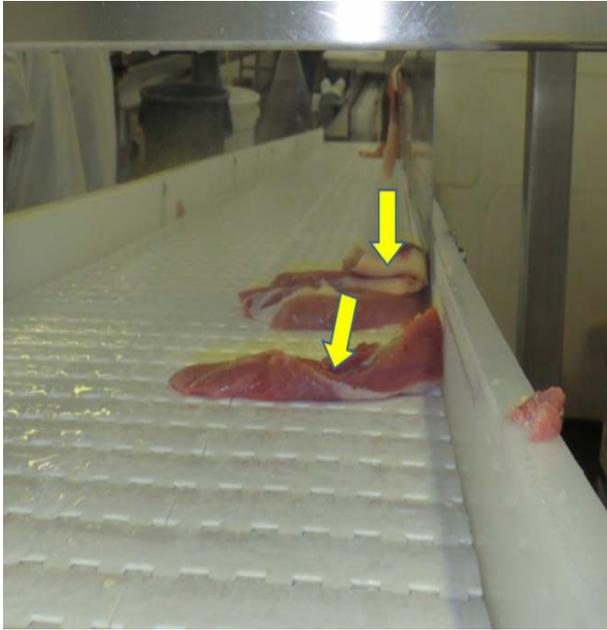
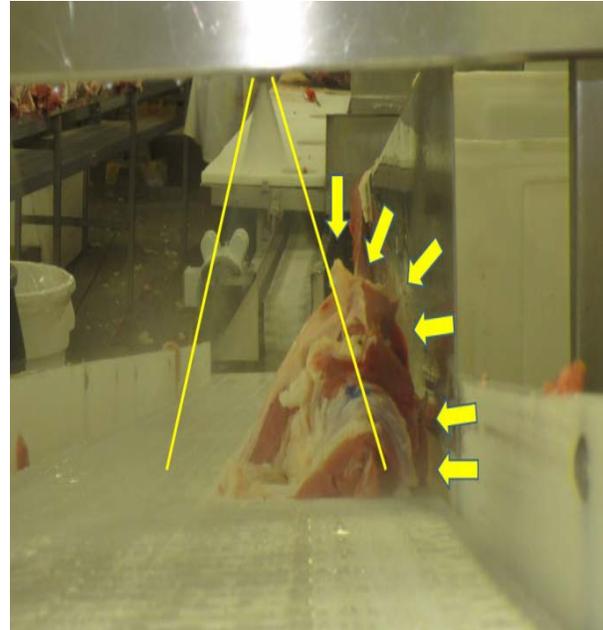
These photos show the establishment's failure to implement its trim antimicrobial intervention spray effectively. The intervention did not achieve full product coverage. Product coverage is essential for the intervention to be effective. Both pictures show that the establishment only applies the intervention to the top side of the trim. These pictures also show product that is folded on top of itself so that not all product surfaces received the intervention (in the left picture each piece has a single fold, and in the right picture the trim is piled up). The picture on the right shows clearly that the arc of the spray nozzles (inside each yellow line) is not sufficient to reach product on the sides of the conveyor belt (yellow arrows).

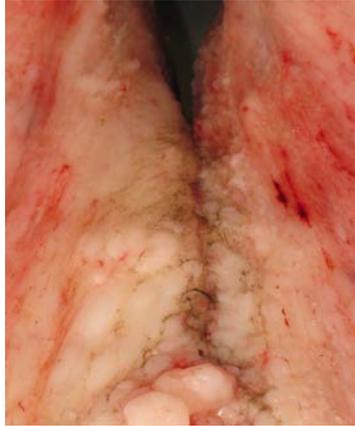
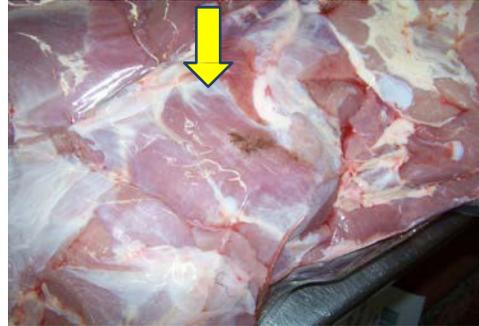
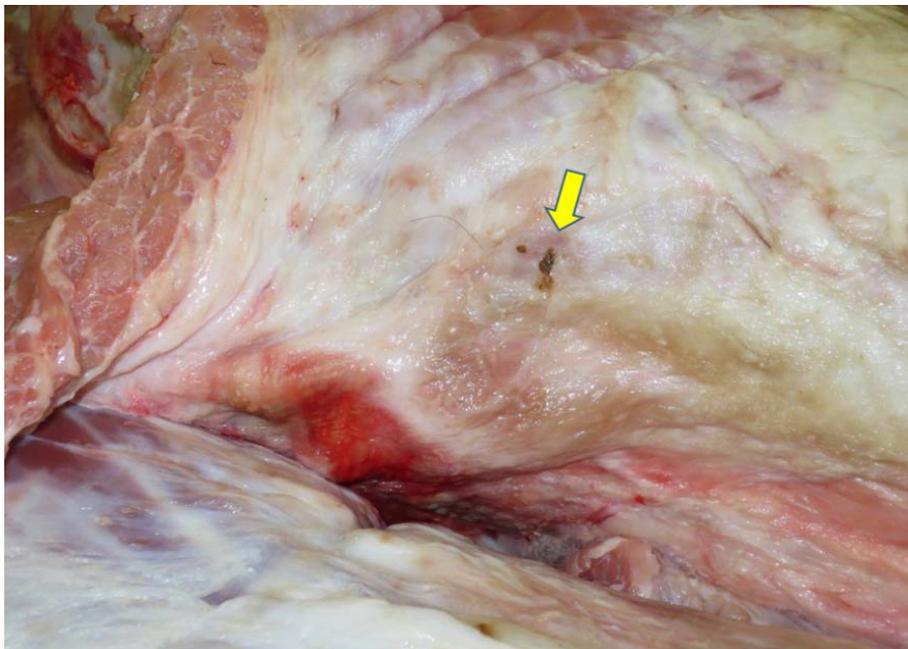
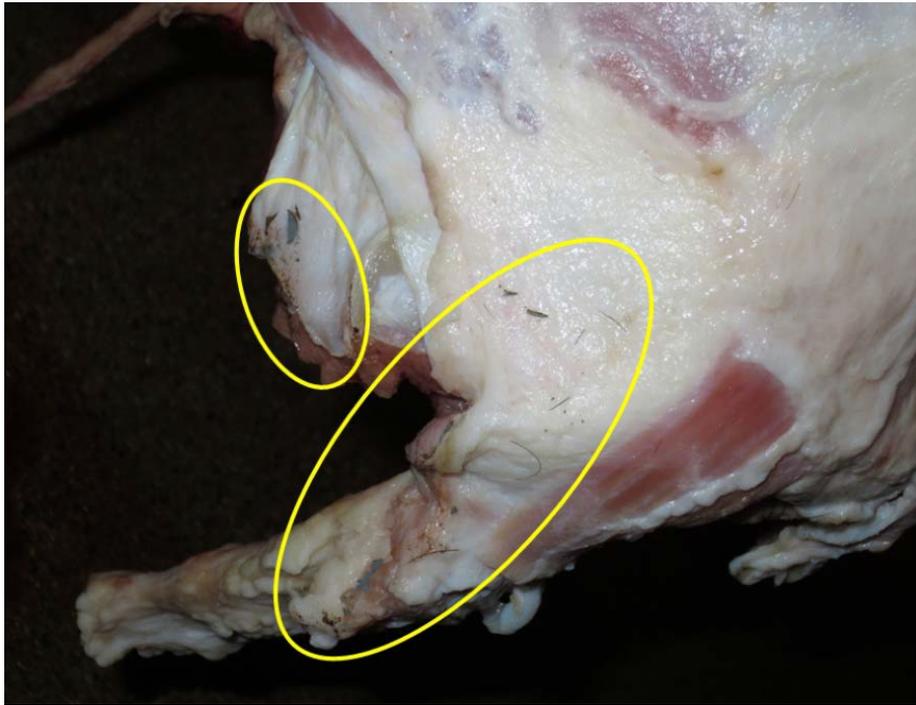
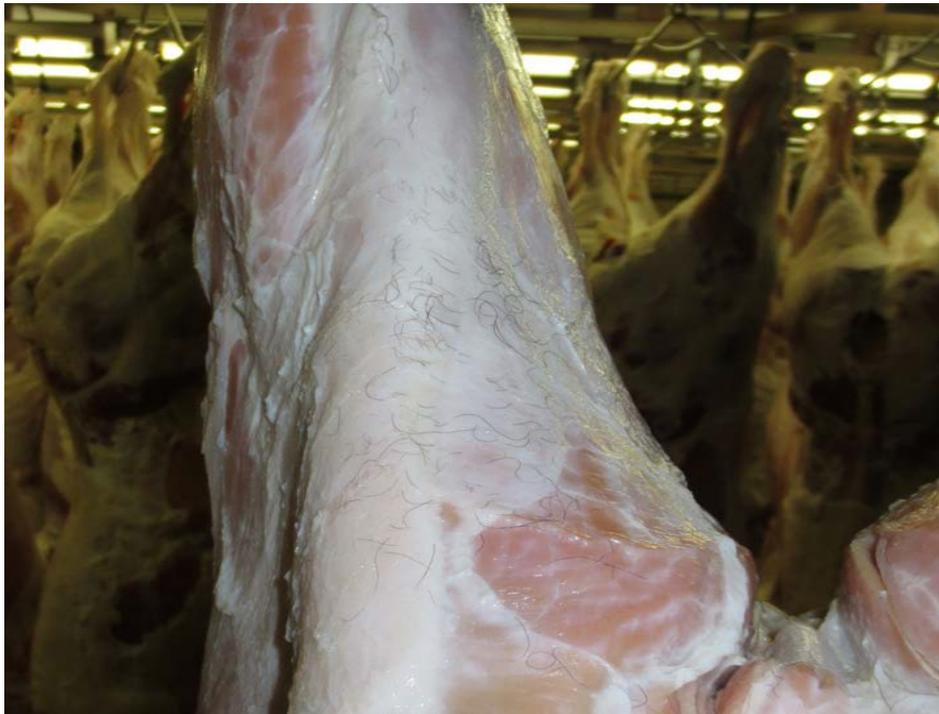
In these photos, we see contamination in the bung area (top left photo), boneless veal legs (top right photo under arrow), breast and shank areas (middle photos under arrow and within ovals), and along the thigh (bottom photo). This contamination resulted from the establishment's failure to implement sanitary dressing procedures to prevent the creation of insanitary conditions and contamination of carcasses, and its failure to implement antimicrobial interventions effectively. Positive STEC test results are a reflection of an establishment's slaughter controls and provide evidence that the establishment is not implementing its slaughter controls effectively to produce safe, unadulterated products.
