Mechanics of Poultry Processing

First Processing

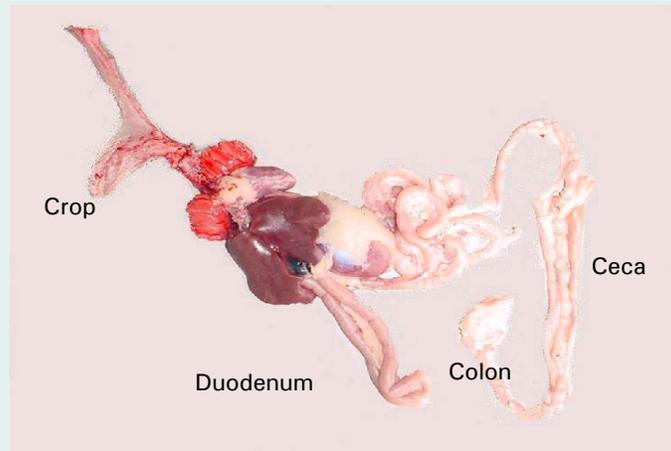
Main locations of pathogens in birds

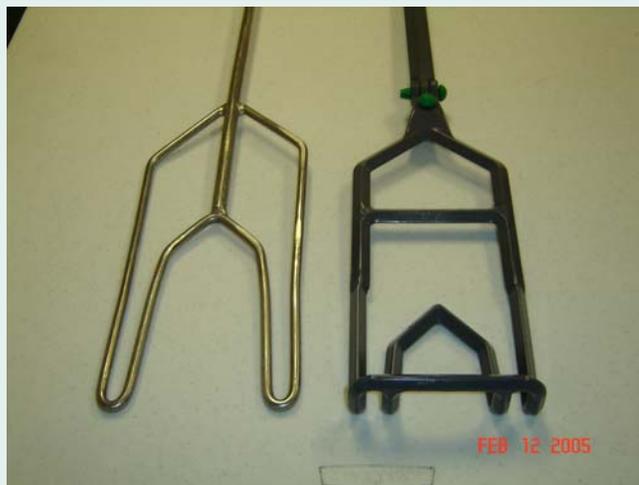
Processing Equipment changes

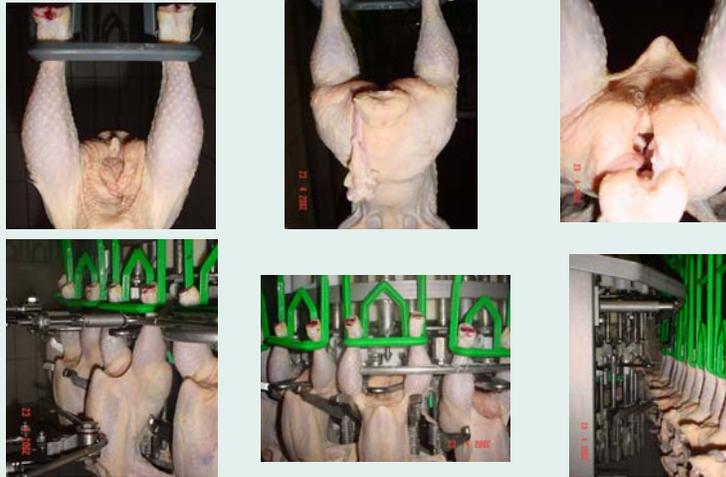
Vent Cutter - photos

Performance failures:

- Missed bird
- Vent still attached to bird
- Rosebud still attached to bird
- Cutting the intestine
- Back, kidney and/or hip damage

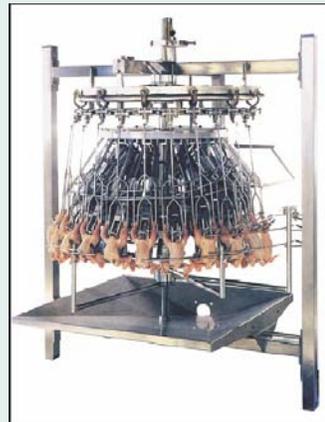
Evisceration – “Draw” Machine

Operational specifications:

- Positioning of carcass
- “Draw” spoon is guided by cam
- Viscera pack is drawn out of the bird
- Lower unit pushes carcass out

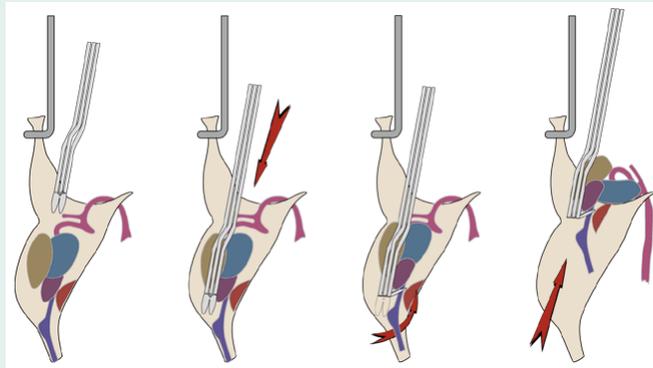
Eviscerator – “Draw” Machine

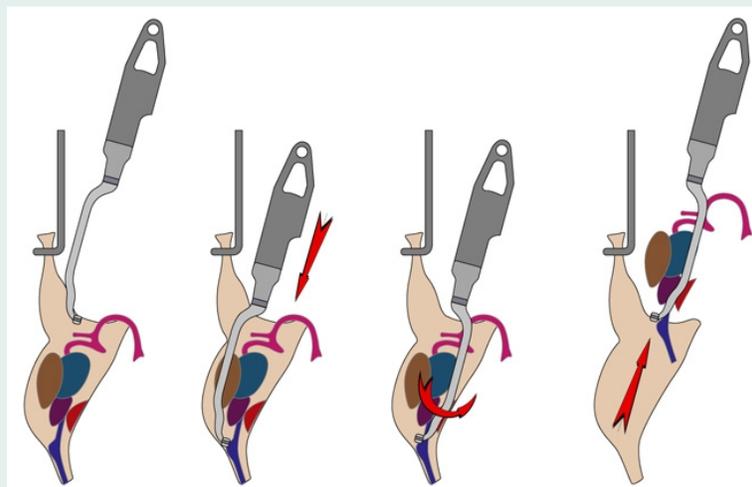
Eviscerator – Maestro

Key actions of the Maestro eviscerator:

- Positioning of carcass
- Accurate positioning of the spoon
- Capturing of trachea and esophagus
- Removal of viscera pack from the bird

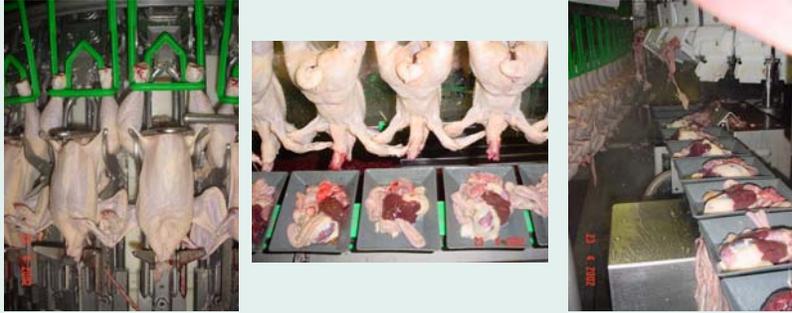
Eviscerator – Maestro

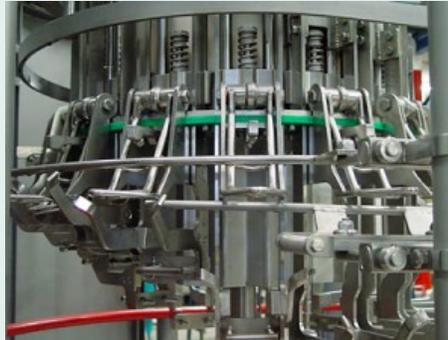
Fecal Removal Machine

Machine operation :

- Location of machine
- Expression of fecal matter
- Rinse of carcass

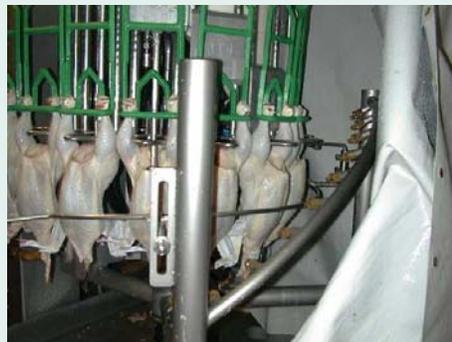
Inside/Outside Bird Washer - IOBW

Machine operation

Below: View of IOBW in operation

- Critical step in process
- Nozzles
- Water usage
